Agricultural Compliance Report (March 19, 2018)

Inspection Date: February 22, 2018

Inspection Type: Permit Reissuance

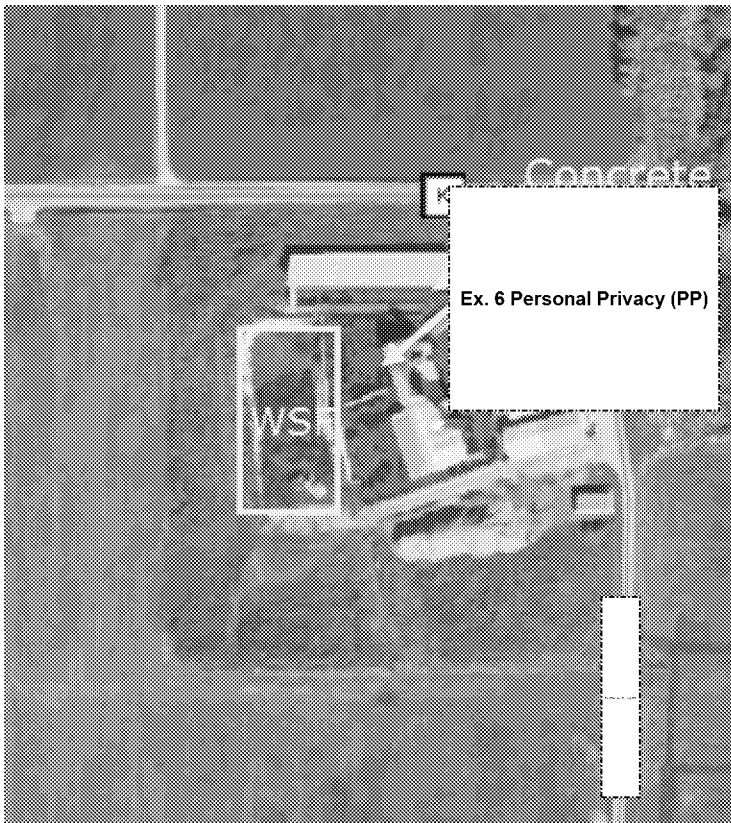
Photo 7 (left). Site overview of Dairy Enterprises— Beef Farm. Purple square indicates the location of wells. Aerial image obtained from SnapMaps v. 16.1.

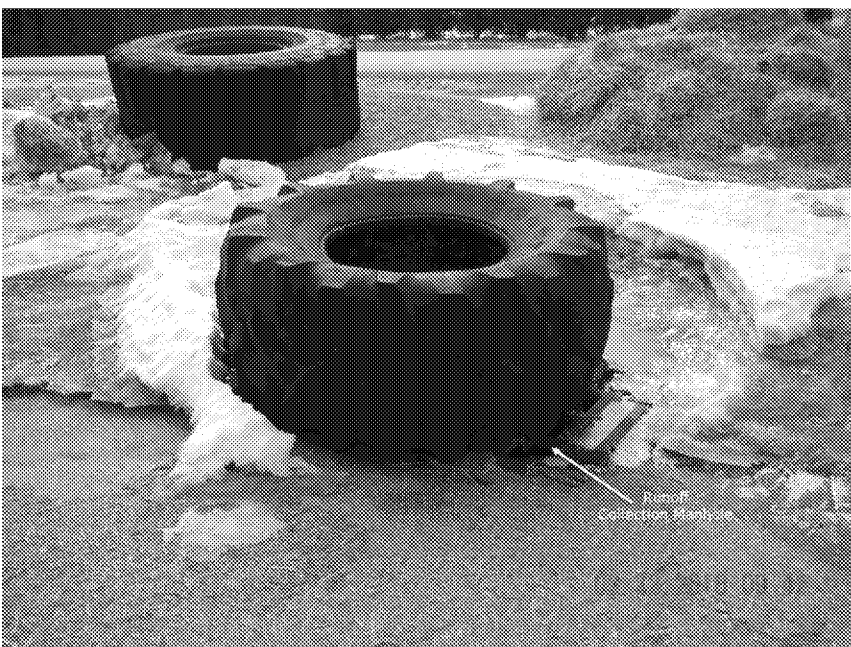
Photo 10 (left). Main Farm—South FSA runoff collection manhole.

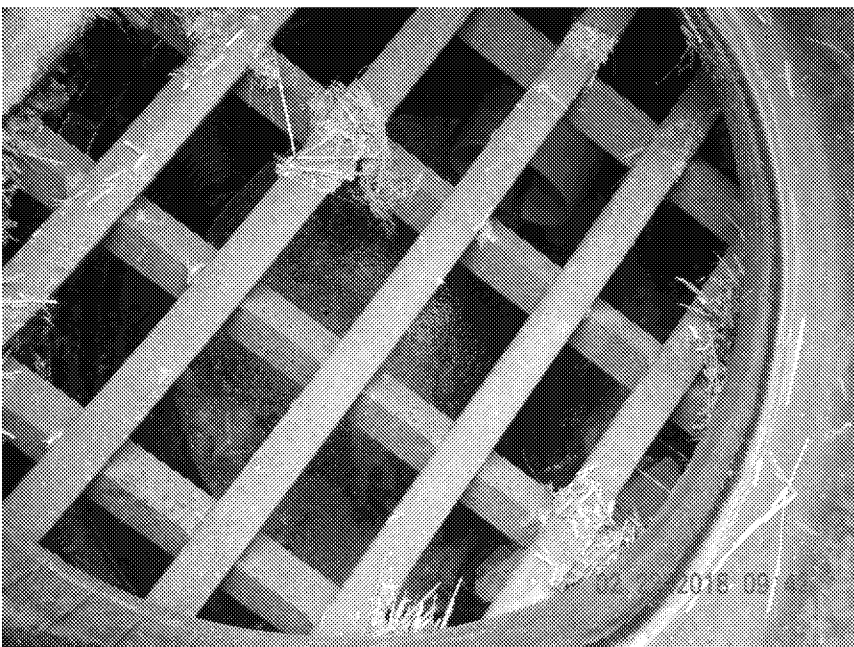
Photo 11 (left). Main Farm—South FSA inside runoff collection manhole.

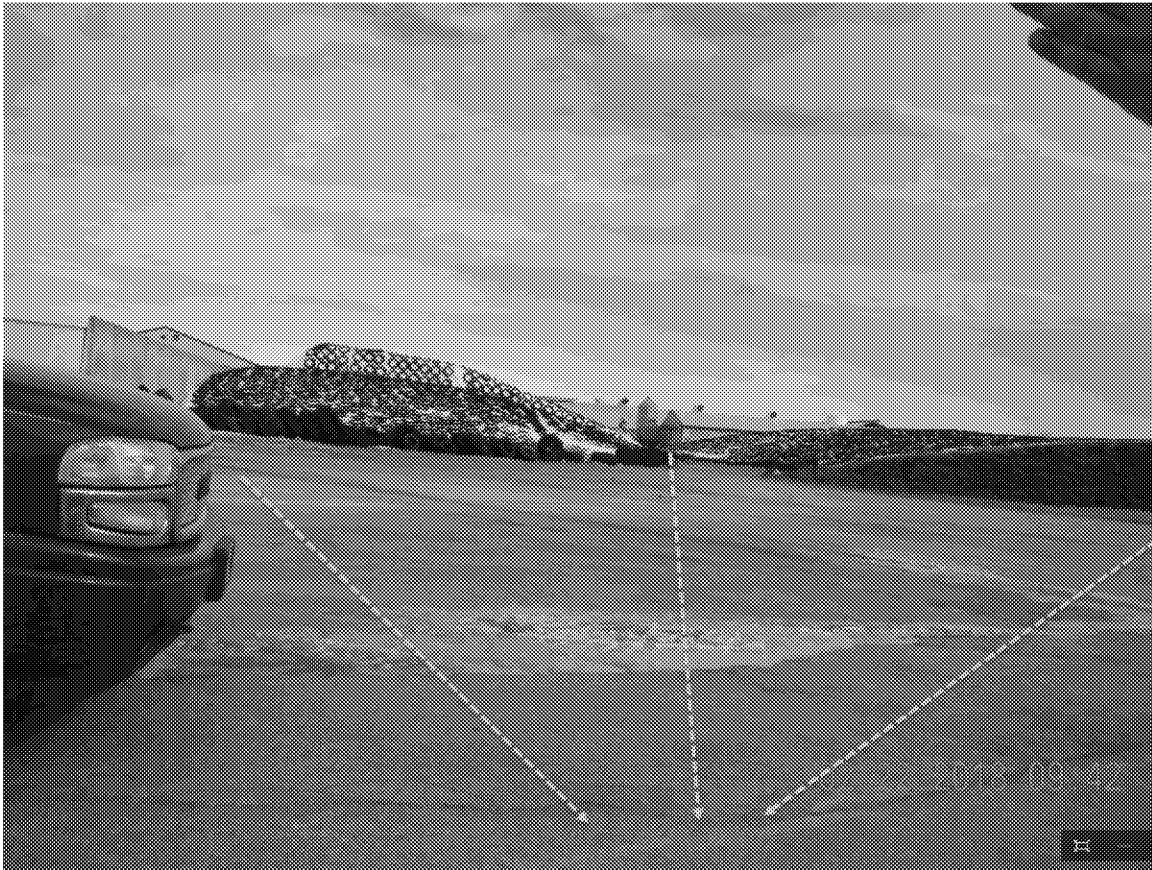
Photo 12 (left).
Main Farm—South
FSA (facing north).
Green dashed
arrows indicate the
direction of runoff
flow.

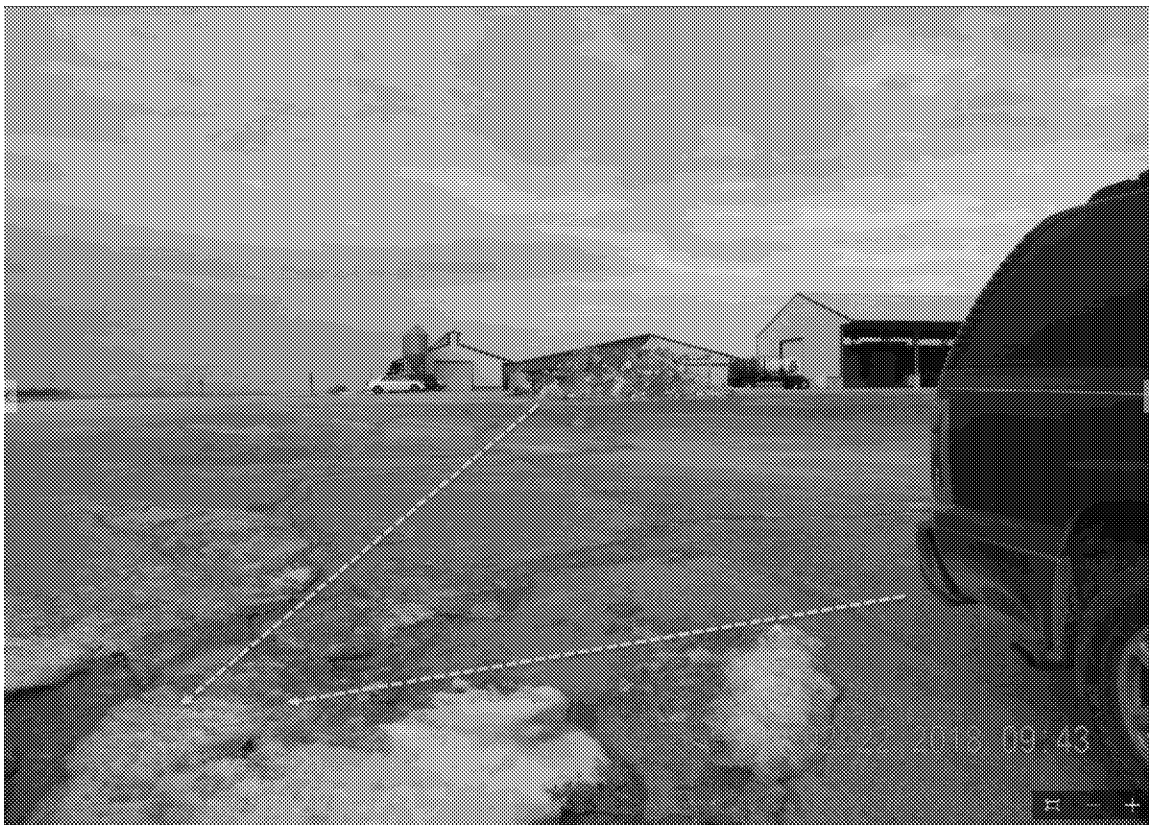
Photo 13 (left).
Main Farm—South
FSA (facing west).
Green dashed
arrows indicate the
direction of runoff
flow.

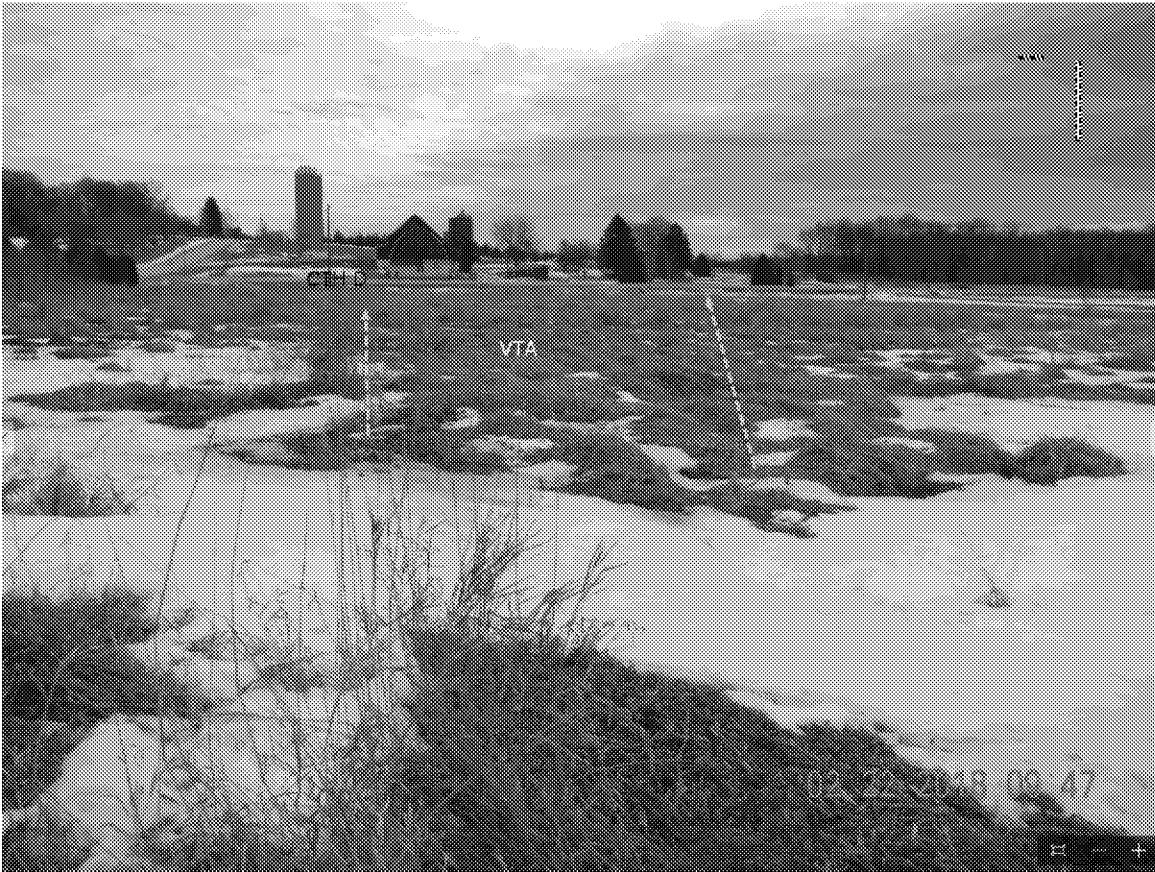
Main Farm: There are two FSAs at the Main Farm: the Main FSA and the South FSA. The Main FSA is located on the northwest corner of the production site. All runoff from this FSA flows south into liquid waste storage facilities (WSFs) 2 and 3. The west end of the pad was also being used for solid manure stacking at the time of inspection. The South FSA is located on the southeast corner of the production site. Runoff from this area flows south to the runoff collection system, which diverts leachate and first flush to WSF 1; the remainder of the runoff is transferred south under 10th Road to a vegetated treatment area (VTA), which was dormant at the time of inspection.

Photo 16 (left).
Main Farm—South FSA, west side of VTA (facing east). Green arrows indicate the direction of runoff flow.

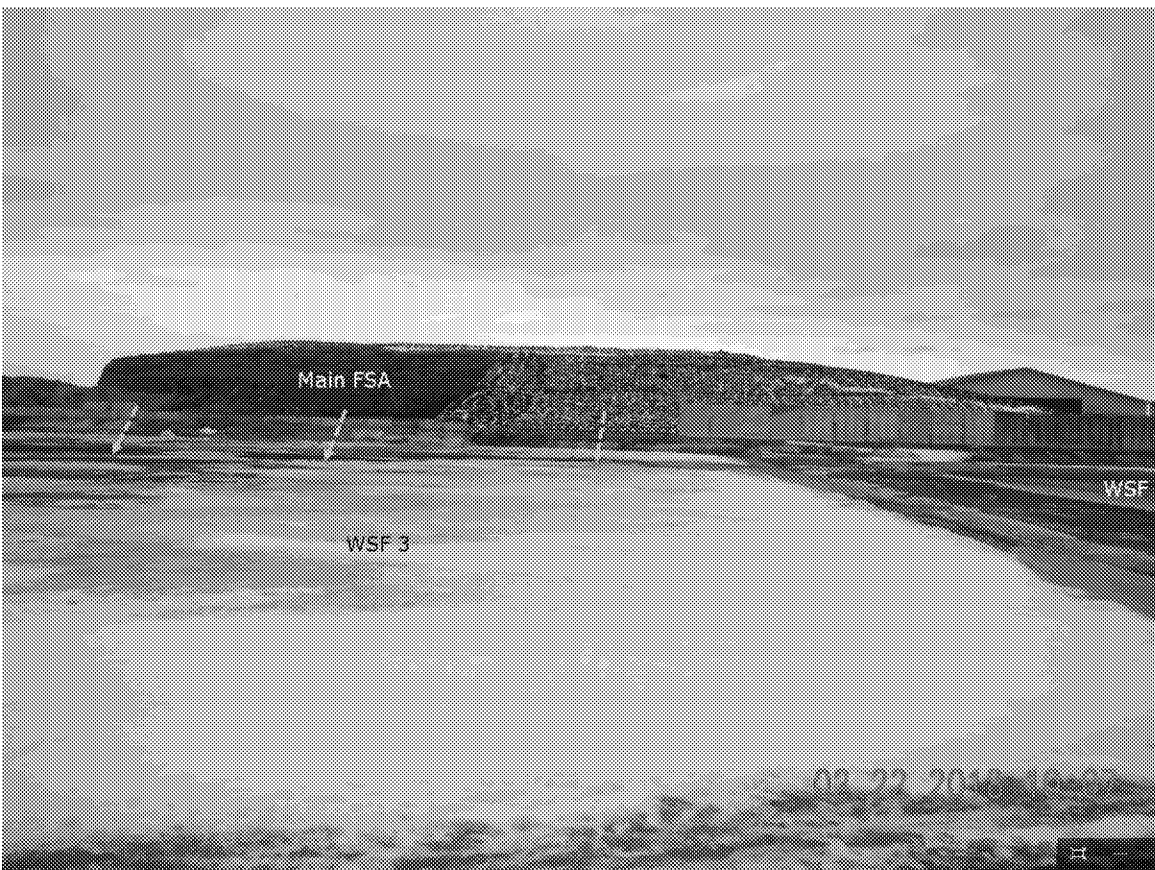
Photo 17 (left).
Main Farm—Main FSA (facing north). Green dashed arrows indicate the direction of runoff flow.

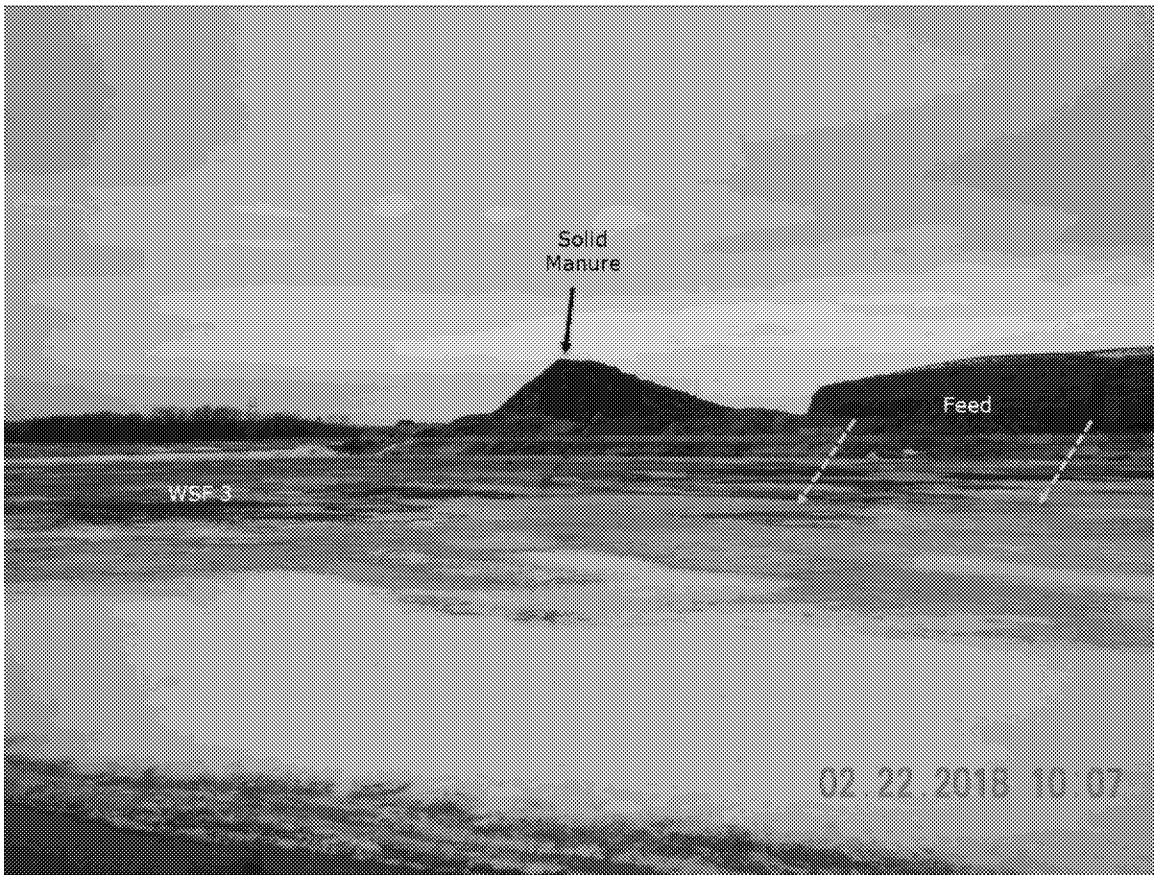
Photo 18 (left).
WSF 3 and south side of Main Farm—Main FSA (facing northwest). Green and red dashed arrows indicate the direction of runoff flow.

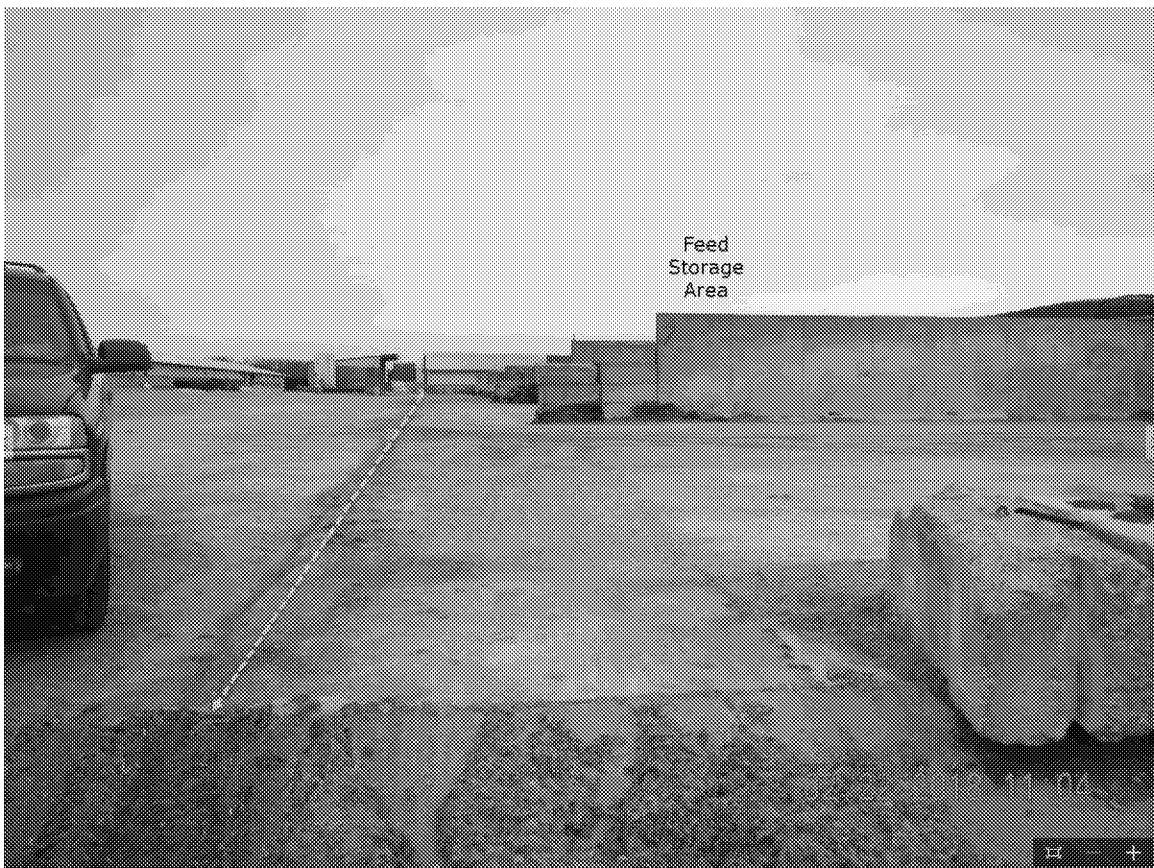
Photo 19 (left).
East end of
Ex. 6 Personal Privacy (PP)
FSA (facing west).
Green dashed arrow indicates the direction of runoff flow.

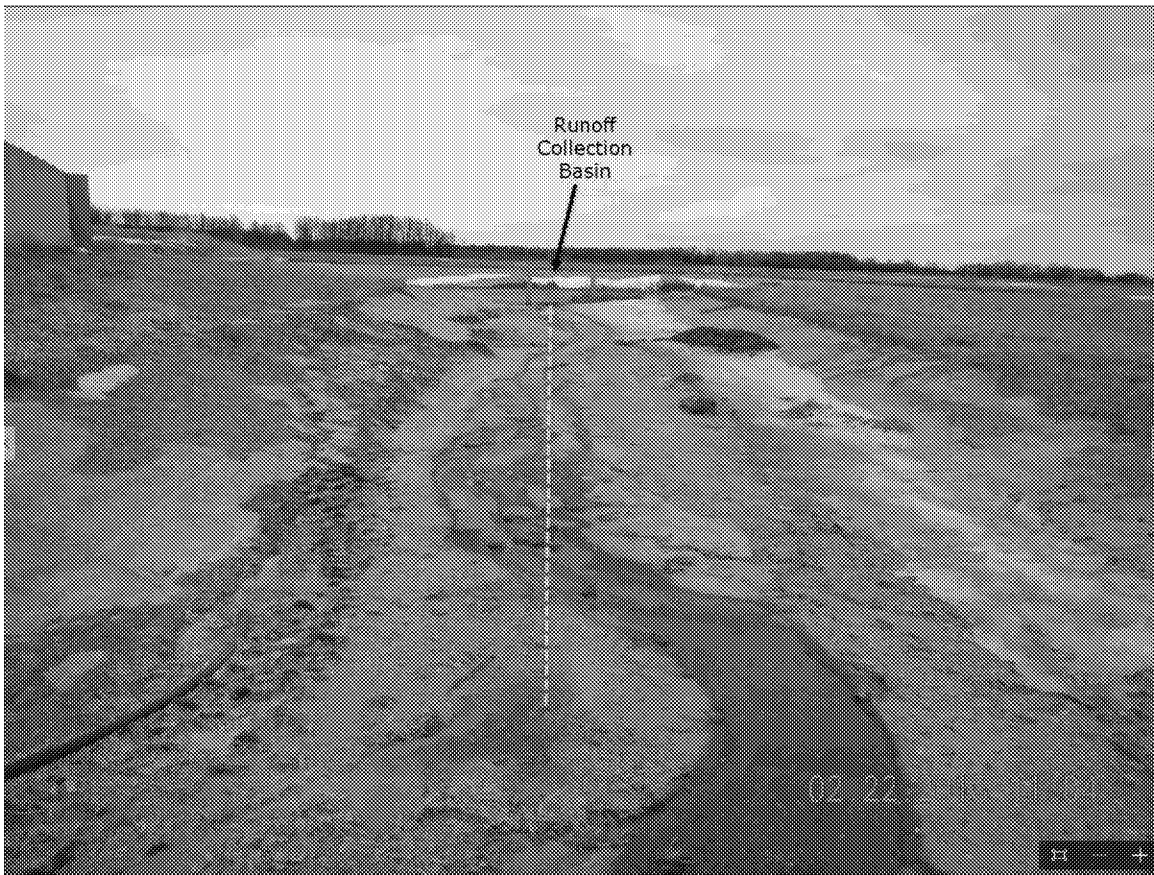
Photo 20 (left).

East end of

Ex. 6 Personal Privacy (PP)
FSA runoff control
system (facing
north). Green
arrow indicates the
direction of runoff
flow.

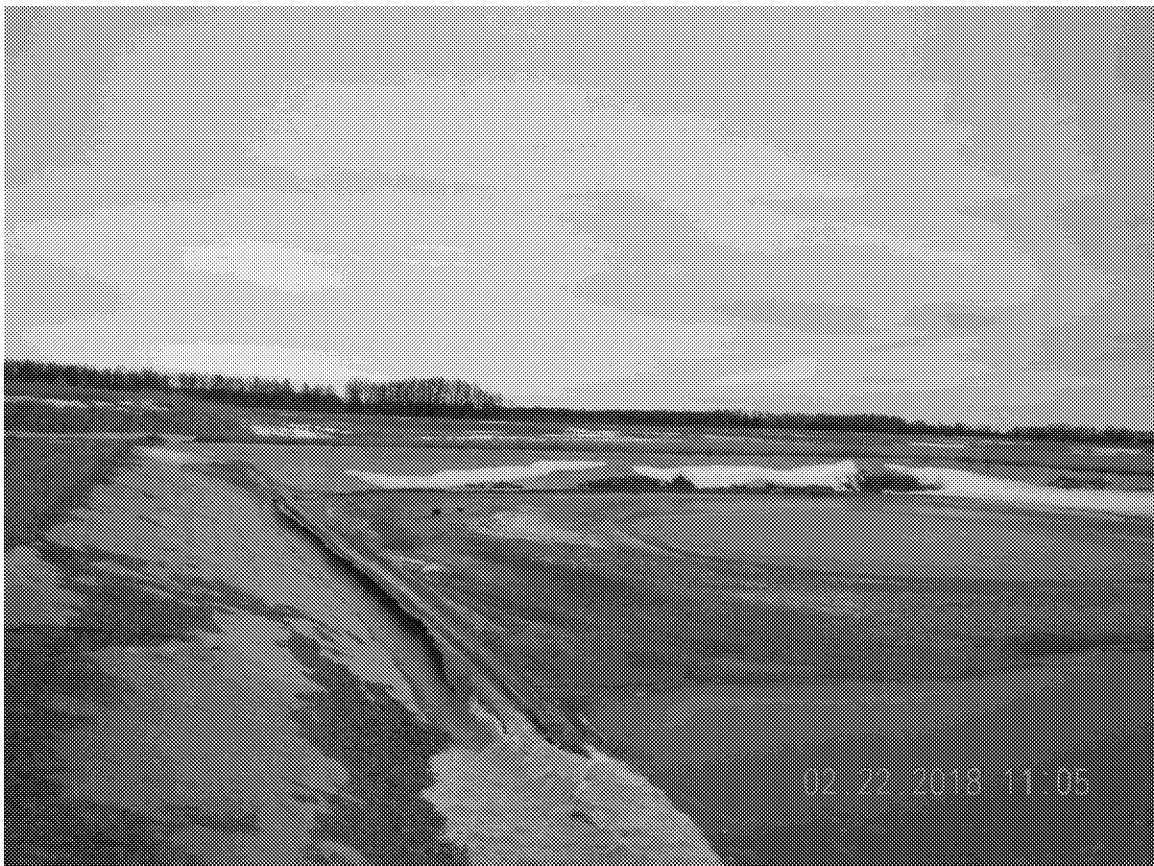
Ex. 6 Personal Privacy (PP) Farm: The FSA at the Ex. 6 Personal Privacy (PP) Farm is located on the south end of the production site. All runoff from this area flows south then east toward a runoff collection basin. The runoff from the collection basin is then transferred to WSF 2 via pump operated by a float switch.

Photo 21 (left).

Southwest corner
of runoff collection
basin at Ex. 6 Personal Privacy (PP)
Farm (facing
northeast).

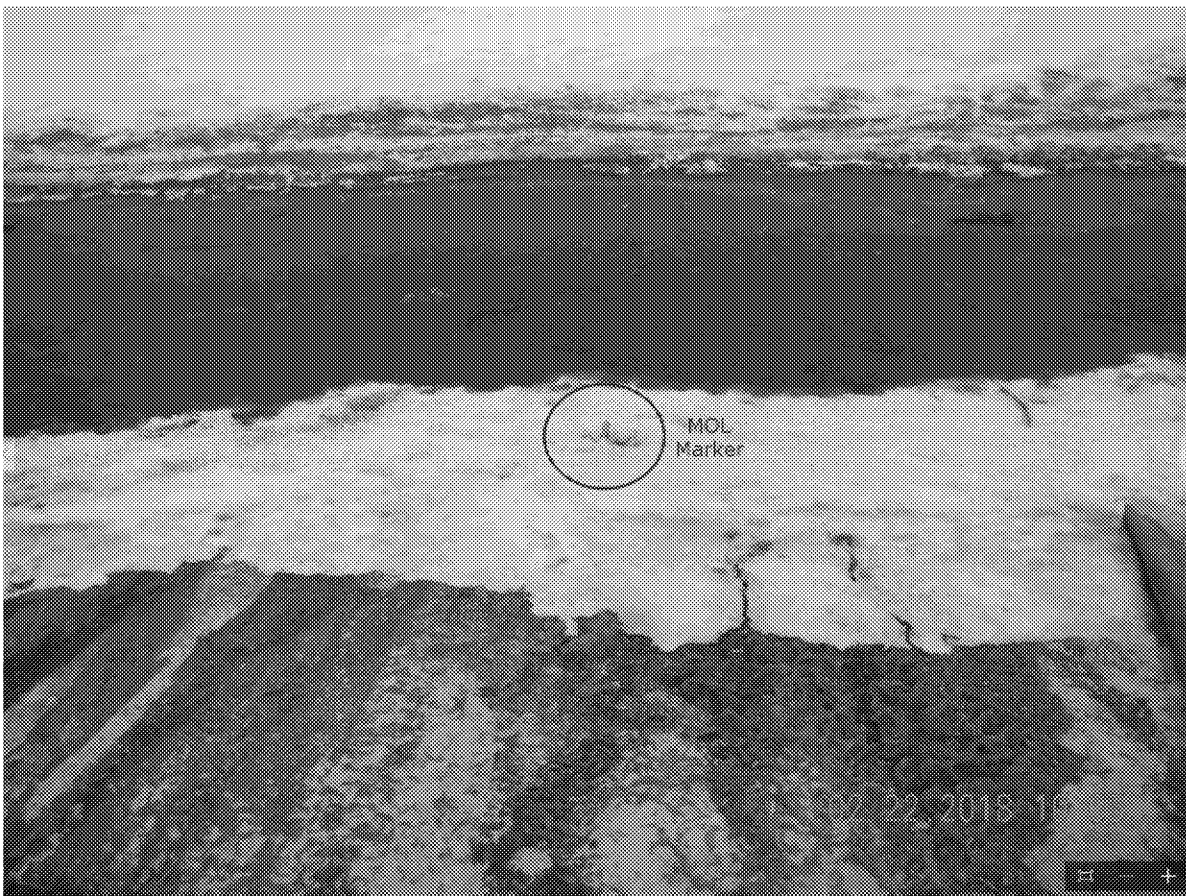
Main Farm: There are three liquid waste storage facilities at the Main Farm that are part of a three-stage storage system connected via overflow weirs. Runoff from the South FSA is transferred to WSF 1. Liquid manure from the freestall barns post-sand separation is transferred to WSF 2. Runoff (feed and solid manure) from the Main FSA flows directly into WSFs 2 and 3. WSF 1 is a concrete storage that was constructed in 2002. WSF 2 is a concrete storage that was constructed in 2006. WSF 3 is a concrete storage that was constructed in 2011. Fencing was present around all liquid WSFs. MOL and MOS markers were present in WSF 3, but not in WSF 1 or 2.

Photo 26 (left).
MOL marker in
southeast corner
of WSF 3.

- Engineering evaluation of WSF 1 at [Ex. 6 Personal Privacy (PP)] Farm.
- Clean up manure tracking from barns at the [Ex. 6 Personal Privacy (PP)] Farm and provide photo documentation and a description of housekeeping best management practices that will be implemented.
- Install permanent markers (Maximum Operating Level and Margin of Safety) in liquid waste storage facilities (Main Farm: WSF 1, WSF 2, WSF 3; [Ex. 6 Personal Privacy (PP)] Farm WSF; [Ex. 6 Personal Privacy (PP)] WSF 1, WSF 2, Runoff Collection Basin; [Ex. 6 Personal Privacy (PP)] WSF 1, WSF 2). Provide photo documentation of marker installation and marker level calculations.
- Install fencing around liquid waste storage facilities that currently do not have fencing ([Ex. 6 Personal Privacy (PP)] Farm). Provide photo documentation of installation.

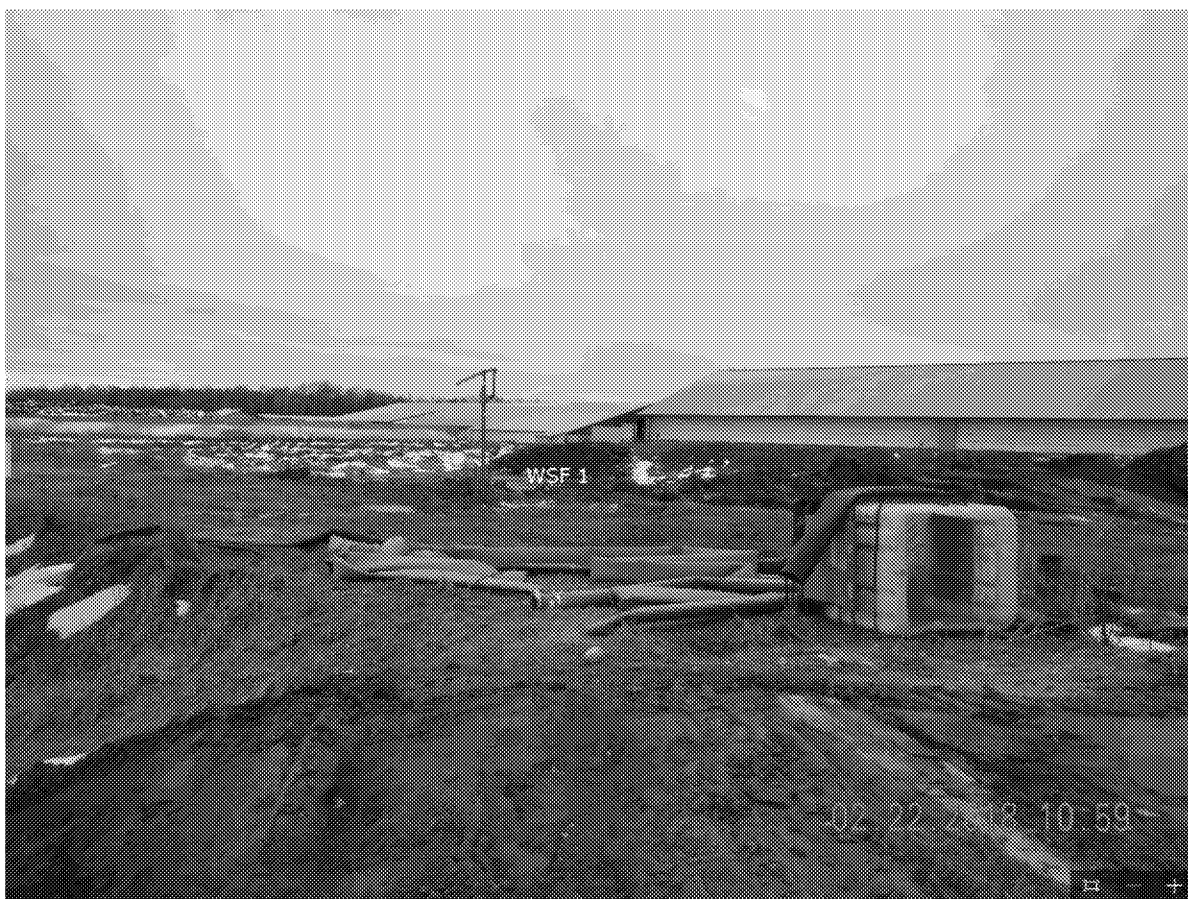
Ex. 6 Personal Privacy (PP) Farm: There are two liquid waste storage facilities at the Ex. 6 Personal Privacy (PP) farm that are part of a two-stage storage system connected via pipe. Manure and process wastewater from the barns is transferred to WSF 1 (west); runoff from the outdoor concrete lot and feed storage area is transferred to WSF 2 (east). WSF 1 is a clay-lined storage that was constructed in 1996. WSF 2 is a clay-lined storage that was constructed in 2007 and last evaluated in 2013 and found to be noncompliant with permit requirements. Subsequent management modifications (lowering the proposed MOL marker height) have been made to WSF 2 to return it to compliance with permit requirements. Fencing was not present around the WSFs. MOL and MOS markers were not present in the WSFs.

Photo 28 (left).
Northeast corner
of WSF 1 at the
Ex. 6 Personal Privacy (PP) Farm
(facing
southwest).

- Perform any necessary upgrades to WSF 1 pending engineering evaluation review.

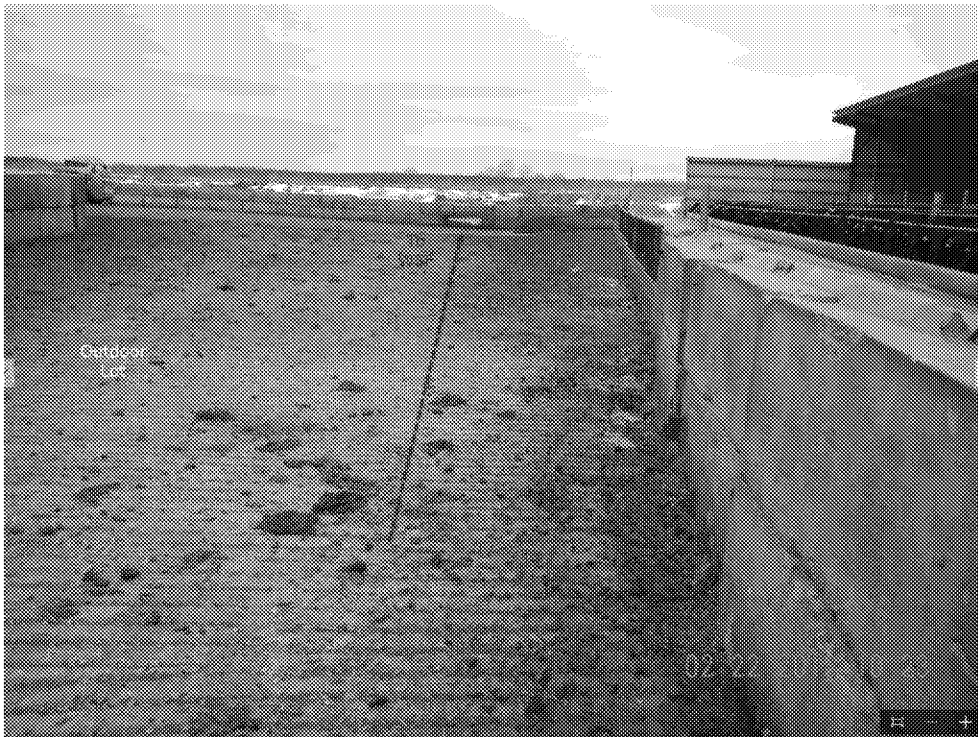
Photo 33 (left). Northeast corner of outdoor concrete lot at the Ex. 6 Personal Privacy (PP) Farm (facing west). Red dashed arrow indicates the direction of runoff flow.

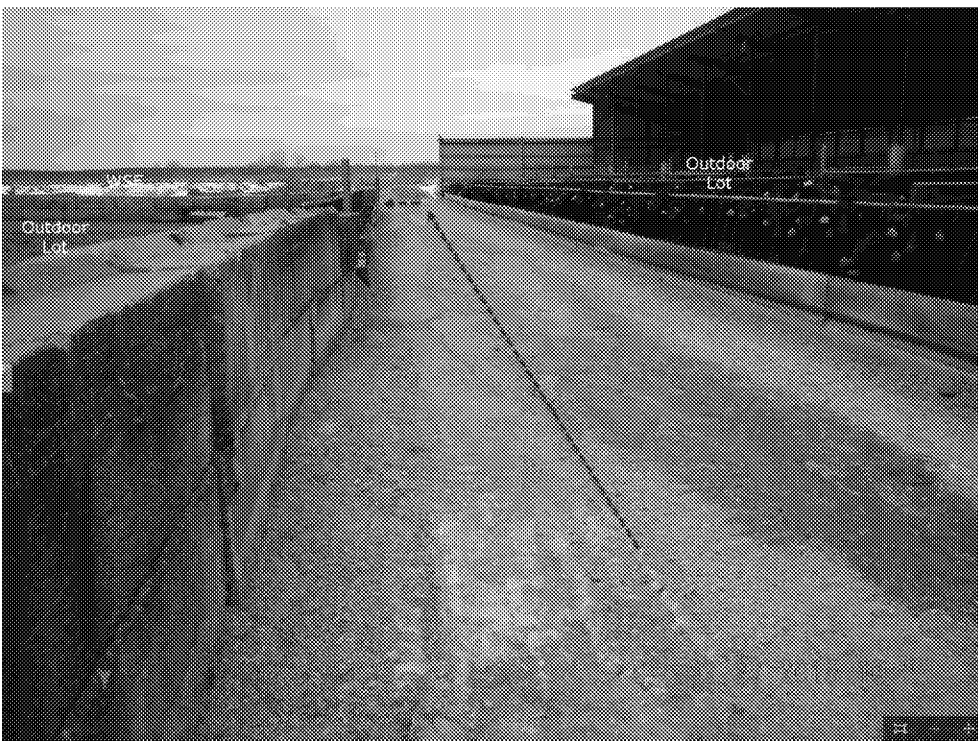
Photo 34 (left). Northeast corner of outdoor concrete lots at the Ex. 6 Personal Privacy (PP) Farm (facing west). Red dashed arrows indicate the direction of runoff flow.

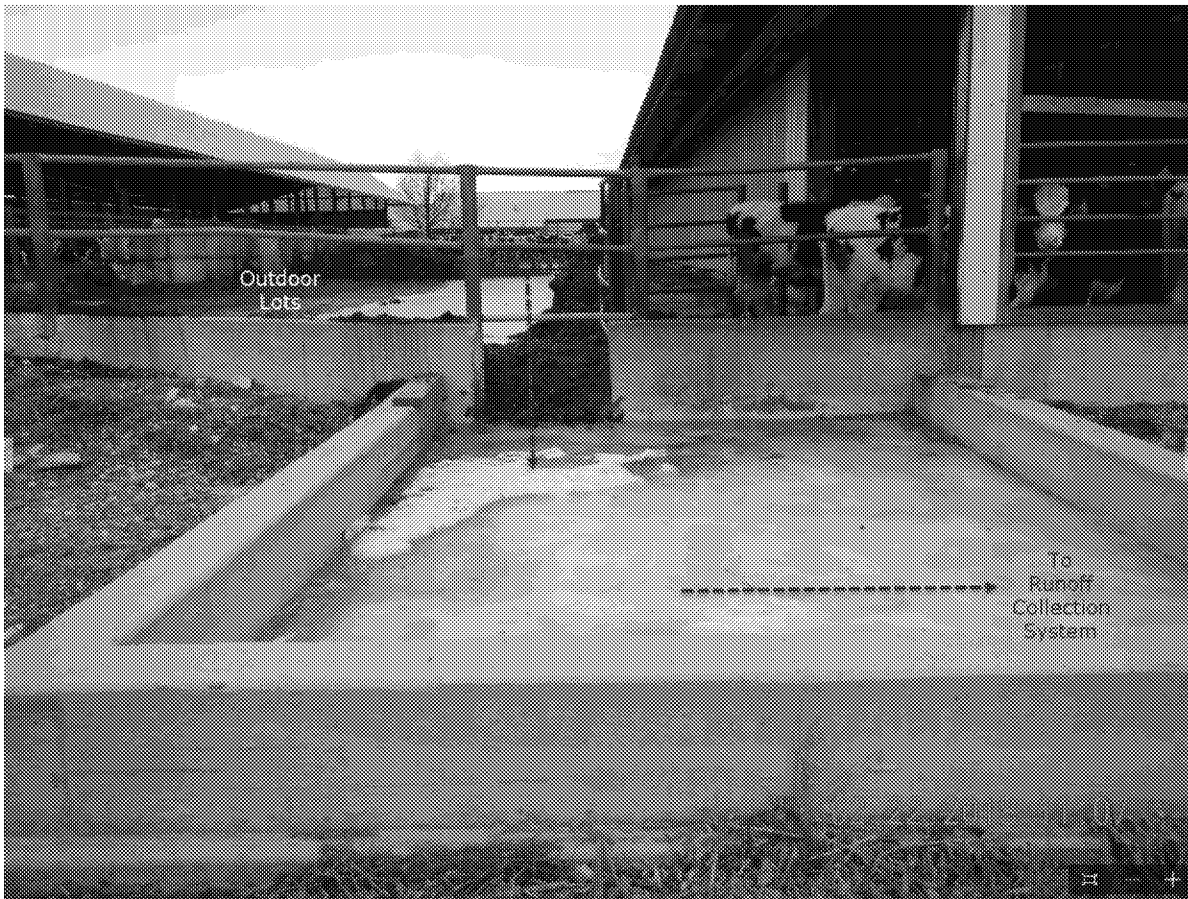
Ex. 6 Personal Privacy (PP) Farm: There are two outdoor concrete lots at the Ex. 6 Personal Privacy (PP) Farm. Runoff from the outdoor lots flows to the south, then to the east and is collected by the feed storage runoff collection system and transferred to WSF 2.

Photo 35 (left).
South end of
outdoor
concrete lots at
the Ex. 6 Personal Privacy (PP)
Farm (facing
north). Red
arrows indicate
the direction of
runoff flow.

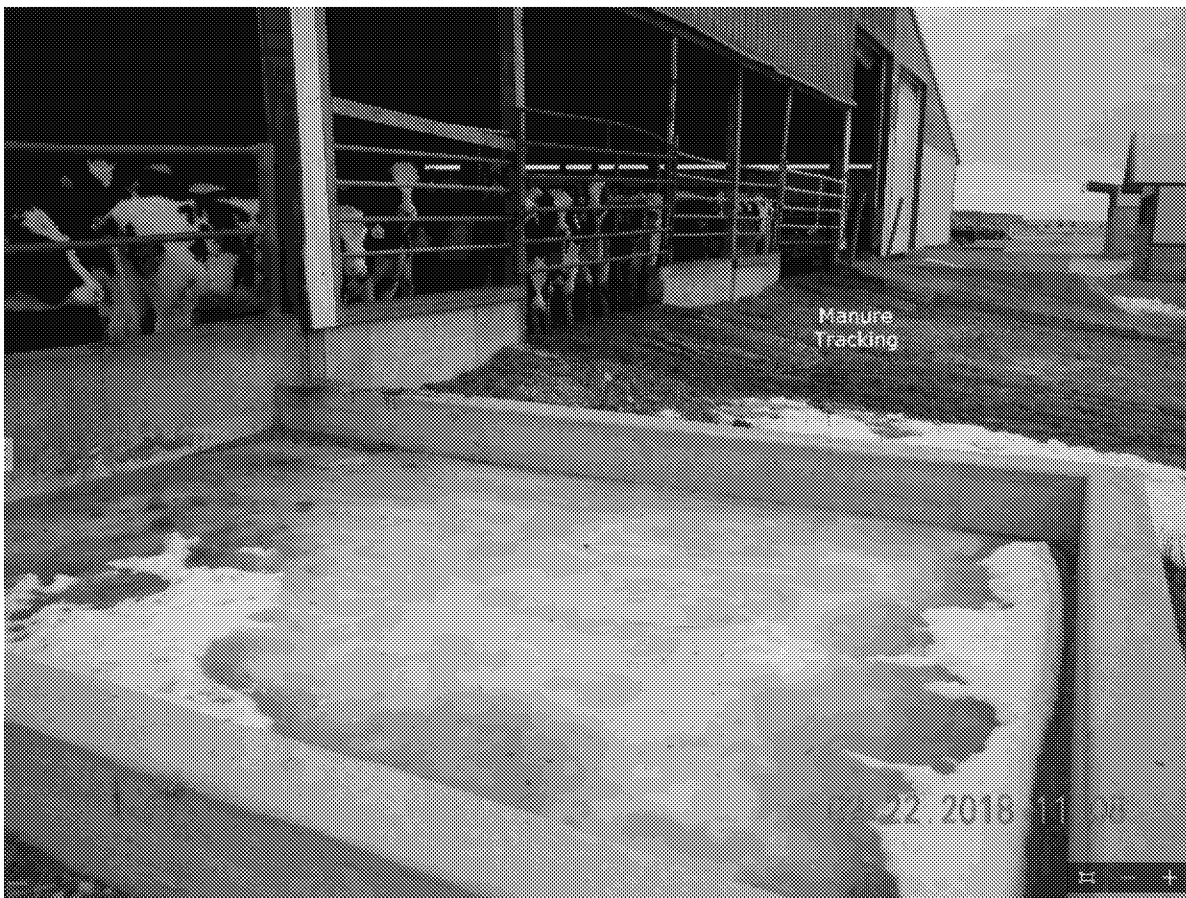
Farm: Manure tracking was observed outside of the barns adjacent to the outdoor concrete lots. Good housekeeping practices should be implemented to ensure that manure discharges to the Unnamed Tributary to Lake Michigan from the production site do not occur. No discharges were observed at the time of inspection.

Photo 38 (left).
 Manure tracking
 out south end of
 freestall barn at
 the Farm (facing
 east). Red
 arrows indicate
 the direction of
 runoff flow.
